Test Report

Report No. A2190008170101

Sample Name Nautilus
Type RFPC-SMA15-FN, RFPC-SMA16-FN
Sample Receiving State Normal
Sample Received Date Jan. 10, 2019
Testing Period Jan. 10, 2019-Jan. 17, 2019

No.	Test Item
1	IPX8
2	IP6X

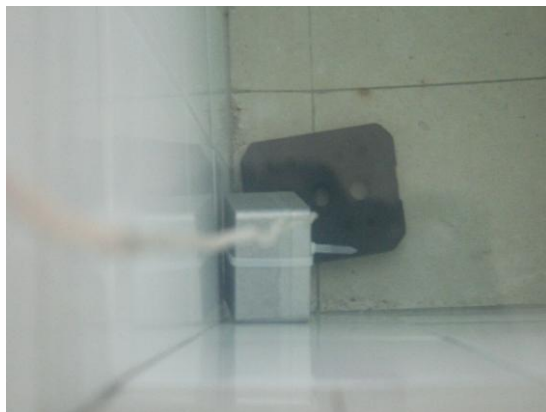
The lowest point of the sample is located 1000 mm below the surface of the water.

The highest point of the sample is located 150 mm below the surface of the water.

Test duration: 48 hours

Test Photo(s)

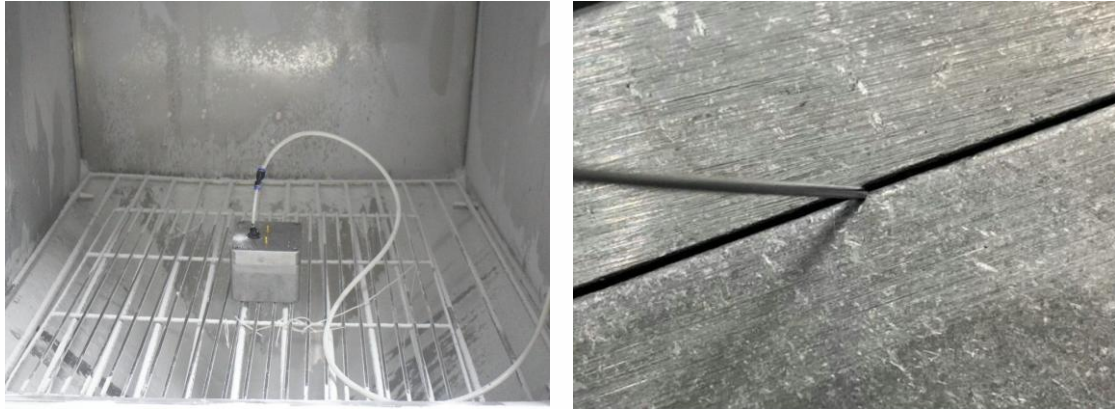
The Test prober of 1 mm diameter is pushed against any opening of the sample with force of 1 N

Set the sample in the dust chamber, the pressure inside the enclosure is maintained below the surrounding atmospheric pressure by a vacuum pump (Pump speed: 864 mL/min, 40~60 times of the shell volume per hour; the differential pressure between the containment and the atmosphere: 1.1 kPa)

Test Photo(s)
